DESCRIPTION

CAUSE OF EVENT

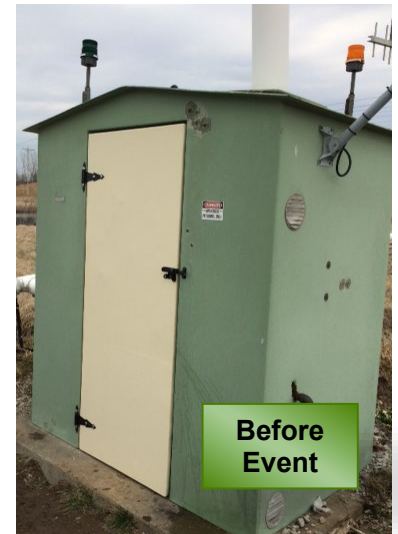
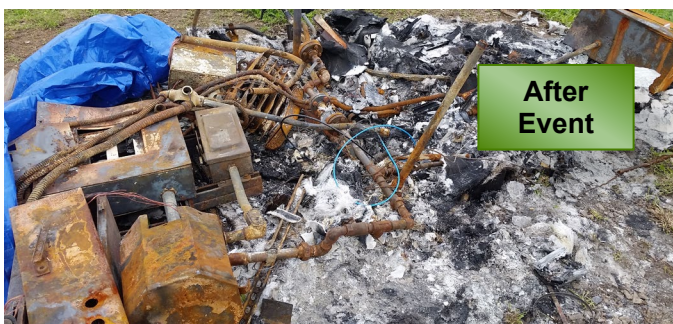
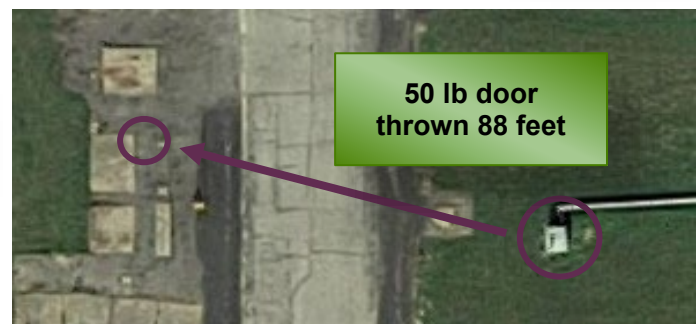
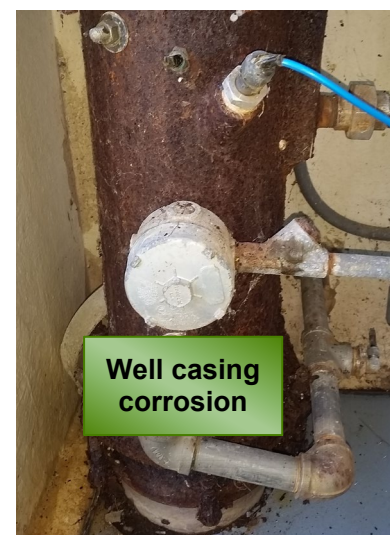
- Small explosion/fire at extraction well operated by 3rd party contractor
- Prior to explosion/fire:
 - PLC upgraded
 - Well cleaned and casing ventilation modified
 - Pump replaced
- Due to PLC issue, well was run in manual mode for ~ 4 weeks
- Explosion threw door 88 feet and fire destroyed well house

- Flammable atmosphere from naturally occurring flammable gases in well
- Corroded well casing released flammable gases into well house
- Insufficient ventilation of well house allowed accumulation of flammable gases in well house
- Lack of control of ignition sources in well

- Well casing replaced
- Well house redesigned for potential flammable gases from well
- Well house ventilation system added to site Asset Integrity program
